REPORT ON SPRINKLER EXPLOSION IN KRISTIANSAND 15. JUNE 2020

RISKS AND RECOMMENDED ACTIONS

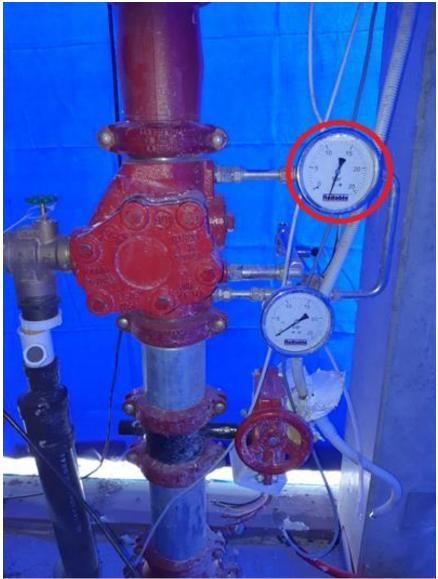
When the plumber arrives, he observes that the manometer which shows the pressure in the sprinkler system itself, has passed the scaling in the manometer. The manometer ends at 25 bars (the picture below was taken about a week after the incident and shows regarding to the distance on the manometer itself, that the needle is at roughly 30 bar). Normal pressure is approx. 7 bars.

Picture 1 Control valve with manometer

The plumber perceives that the manometer appears to be damaged. As part of the work of replacing the manometer, the plumber decides to empty the sprinkler system. The plumber stands in the technical room and observes the emptying. Then suddenly the room explodes with a bluish colour.

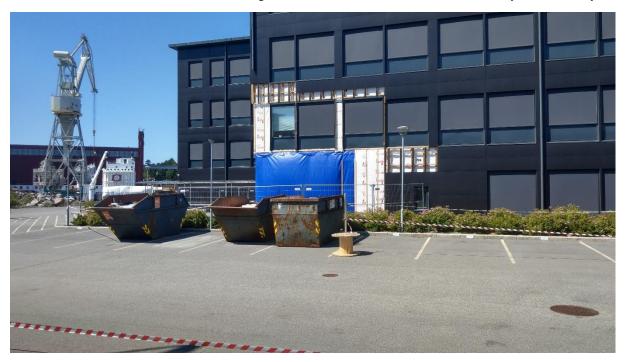
As photos in the media and below show, the building was badly damaged. The outer walls around the technical room where the sprinkler control unit stood were literally blown away

Picture 2 Facade

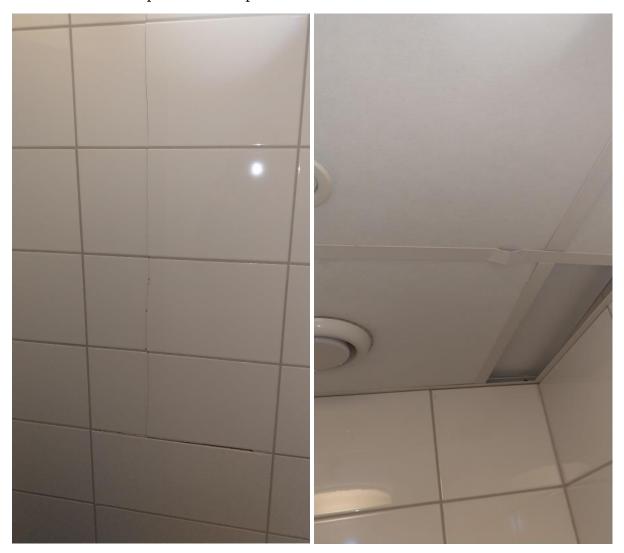
Even deep inside the building, there was significant damage and marks after the explosion, which illustrates the power of the explosion.

Picture 3 and 4 Damage tiles bathroom and ceiling

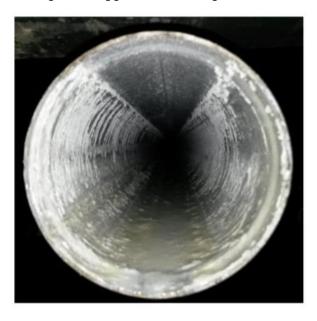
Since the zinc emits electrons faster than the steel itself, it acts as a sacrificial cathode until the zinc has been used up. Unfortunately, all experience now shows that the sink in the air-filled part disappears first (see picture below).

Picture 4 Galvanized pipe after draining on another system
